**Revised LIST OF SOUTH BOUND CRASH BARRIER DEFECTS**

INSPECTION DEPARTMENT
South Bound Crash Barrier
DATE: 12/11/09

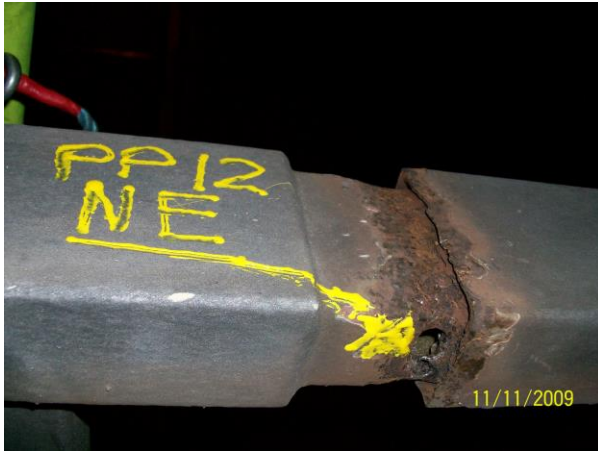
**DEFECT 1.**

COMPLETED	
	NAME	DATE
<b>North East Side Span</b>		
1. P.P. 12 N.E. MALE END HOLED.		
2. P.P. 19-20 N.E. BENT POST (PREVIOUSLY RECORDED).		
<b>North East Main Span</b>		
3. P.P. 56 N.E. MALE END HOLED (UNDERSIDE).		
4. P.P. 62 N.E. MALE END HOLED (UNDERSIDE).		
5. P.P. 86 N.E. POST BASE CRACKED.		
6. P.P.88 N.E. POST BASE CRACKED (FOUR SIDES OF BASE).		
<b>South East Main Span</b>		
7. P.P. 68 S.E. MALE END HOLED (UNDERSIDE).		
8. P.P. 62 S.E. POST BASE CRACKED.		
<b>South East Side Span</b>		
9. P.P. 30 S.E. MALE END SHEARED (OUTSTANDING).		
10. P.P. 28 S.E. MALE END HOLED.		
11. P.P. 22 S.E. POST DAMAGED/WELD BROKEN (OUTSTANDING).		
12. P.P. 12 S.E. REPLACE MALE & FEMALE ENDS.		
ADDITIONAL DEFECT AS OF 30/05/10		
13. P.P.82 N.E. POST HAS BEEN REMOVED DUE TO IMPACT, TOP RAIL HOLED.
