INSPECTION DEPARTMENT
DEFECTIVE AREA ON CONCRETE SOFFIT. C/BEAMS 58-59 N/E VIADUCT.
DATE. 06/04/10

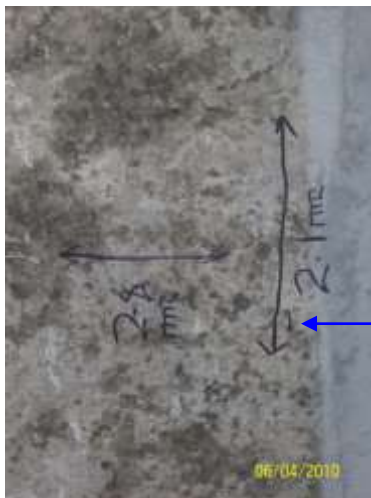
Concrete deck soffit between  
crossbeams 58-59.  
approximate dimensions of  
area inspected.

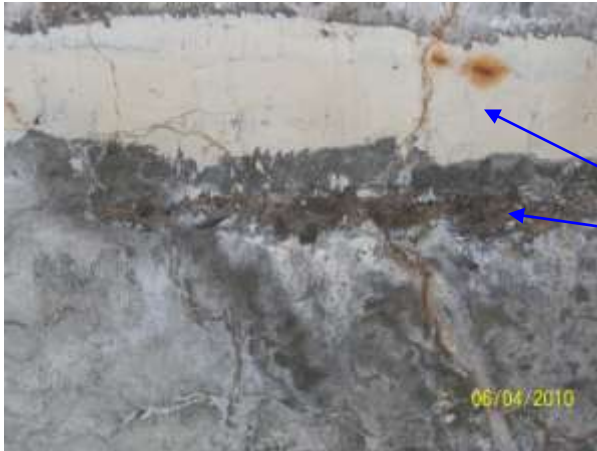
The area on the deck soffit was inspected visually, approximate measurements were taken. Heavy veinular cracking was evident with signs of salts being discharged from the concrete. . Also evident was discoloured transverse area approx 400mm long ( what looked like possible staining coming from a re-bar located closely to the face of the deck soffit. A hammer ring test was carried out over the majority of the damp /discoloured area with no indication of any sub- surface hollow or honeycombed concrete evident.

Discoloured area of concrete (possible sub-surface steel re-bar beginning to show). Also transverse epoxy repair carried out pre- 1990.

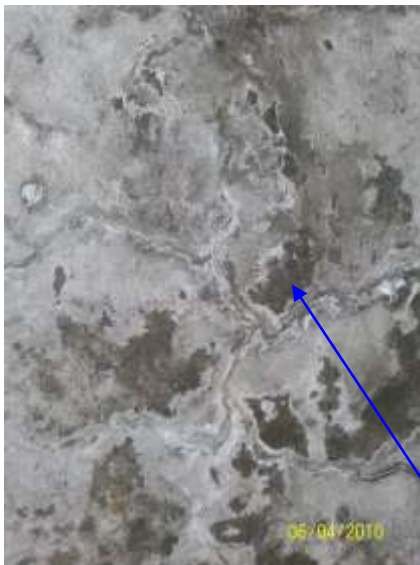
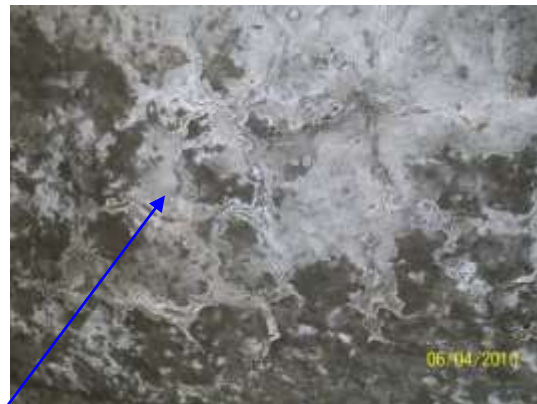
Views of heavy veinular cracking on deck soffit area.
