# A90 Forth Road Bridge Special Inspection Report

North Main Tower Expansion Joint  
Removal & Reinstatement of Side-Span Plate  
SW No.3  
October 2015

#### **North Main Tower Expansion Joint Removal & Reinstatement of Side-Span Plate SW No.3**

**October 2015**

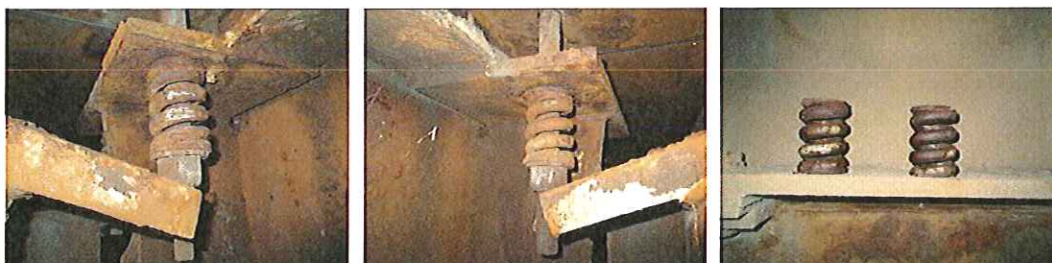
Springs: Tongue plates springs both east & west were intact and secure. General breakdown of protective paint coating on the springs was evident. The continual compression & de-compression of plate movement from vehicle axial load transferral induces break-down. This combined with the location and exposure to the elements creates an environment which exposes the springs and general corrosion is inevitable - this was evident on both springs at the time of inspection. Spring dimensions were recorded prior to removal - spring sizes on both East & West springs were recorded at 72mm. By recording this information this will ensure that new springs can be compressed to this size on reinstatement of the tongue plate. Both blocks located on the east & west side of the plate remain intact & secure.

**General condition of springs during pre-inspection**

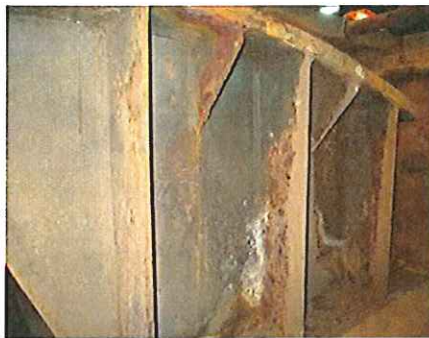
The cell condition was to be as expected although areas of heavy corrosion were evident on the cell steelwork & associated fixings. The majority of the discolouration / staining on the cell steelwork is created by constant ingress of water distributed from the carriageway and through the expansion joint plates. In general the cell steelwork remains in a satisfactory condition.

**Heavy corrosion to cell steelwork**

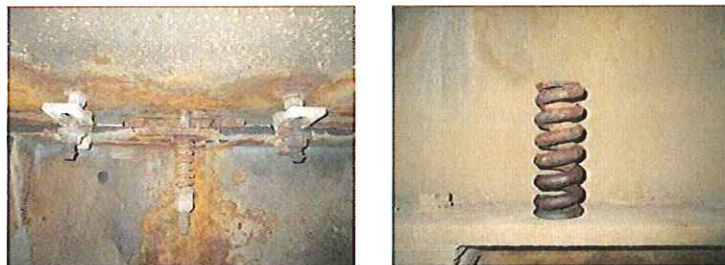
Rocker Spring: Rocker plate spring located centrally in the plate were intact and secure. General breakdown of the protective paint coating on the spring was evident. The continual compression & de-compression of plate movement from vehicle axial load transferral induces break-down. This combined with its location and exposure to the elements creates an environment which exposes the spring and general corrosion is inevitable. This was evident on the rocker spring at time of inspection. Spring dimension was recorded prior to removal, spring size recorded at 140mm. By recording this information this can ensure that new spring will be compressed to this size on reinstatement of the rocker plate.

**Condition of Rocker Plate and Springs**

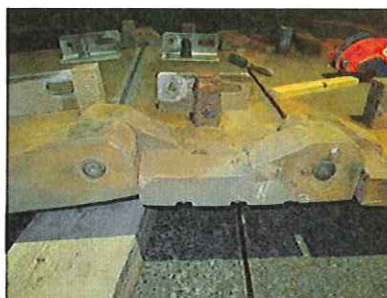
Pins: The sliding plate section pins (as in previous inspections on several plates) were found to be worn and out of shape. All remain in-situ, intact and secure.

**General Condition of Slide Train Pins and Bushes**

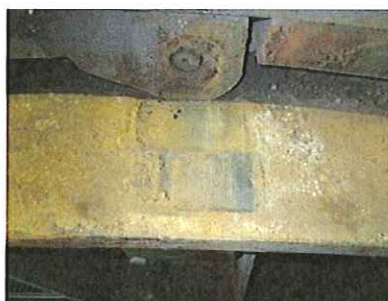
Bushes: All bushes were visually inspected and dimensions recorded. Bush thickness was measured in four locations on both internal & external faces. Wear-down was evident on all bushes. Refer to inspection record sheets within Appendix B for more information.

**Example of Wear to Radius Arm from Bushes**

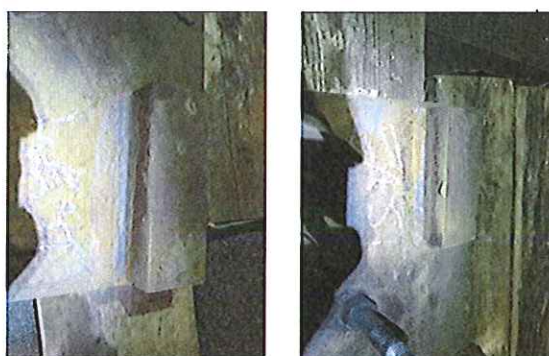
Rocker plate end bearing blocks: Both blocks located on the east & west side of the plate remain in a satisfactory condition. All welds on the rocker plate end bearing support blocks were visually inspected, all both were found to be in a satisfactory condition. It was decided that no further method of inspection would be required. A slight mismatch of levels between the rocker plate end and the deck panel end was recorded. Refer to inspection record sheets within Appendix B for more information.

**Rocker Plate End Bearing Blocks (East and West)**

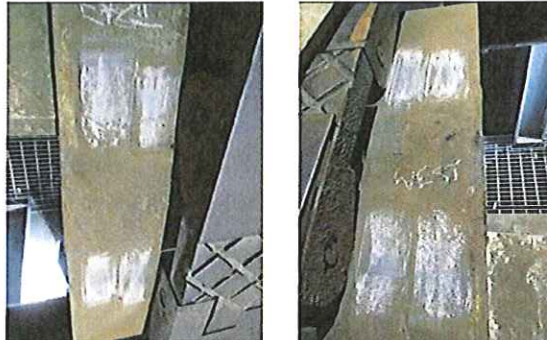
Radius Arm Girders

Radius arm girder: A visual inspection of the radius arm girder was carried out to record the depth of wear down through the constant movement of the sliding plate sections. Refer to inspection record

sheets within Appendix B for more information. The structural integrity of both E & W radius arms remain in a satisfactory condition.

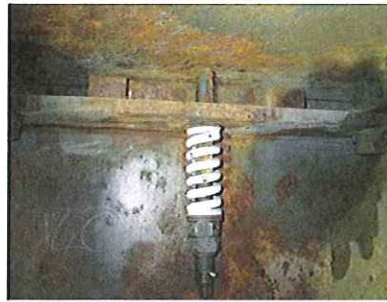
**New spring fitted to rocker plate**

**Rocker plate:** New spring fitted. Tensioned to required pre-removal length of 140mm. Fail-safe bolts fitted. Failsafe train plates fitted & tightened. All satisfactory

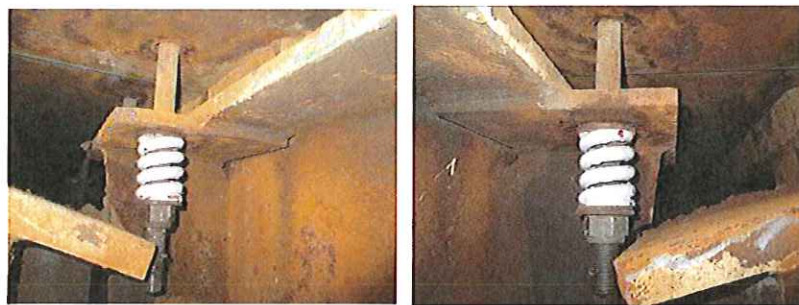
**New springs fitted to tongue plate**

**Tongue plate:** New springs fitted on both East & West. Tensioned to required pre-removal length of 72mm. Fail-safe bolts fitted. All satisfactory.
