Location PP. 20 N/W North west side Span. .  
Bolt change report.

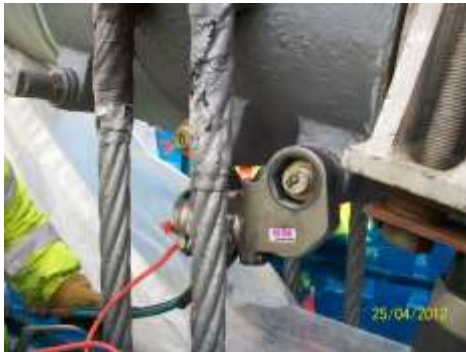
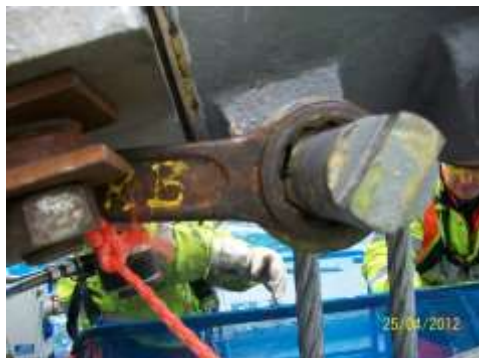
12.25 pm. . Operations to release load on dead side of defective bolt "B" began using RSL 6.

12.30 pm. Bolt began to turn, flogging spanner applied to live side to counteract this movement.

12.40 pm. Bolt released .

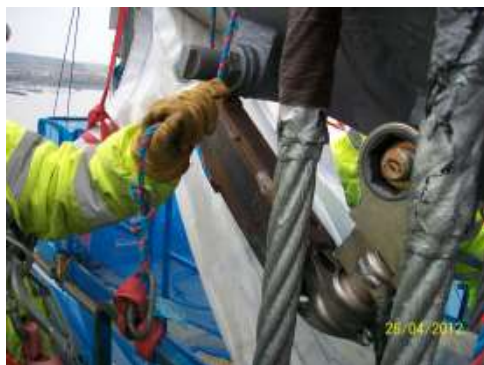
14.20.pm. Began to release Bolt "D". Extension sleeve added by engineer to RSL 6. to be able to gain a reaction point from bolt "F" on the dead side to enable bolt release.

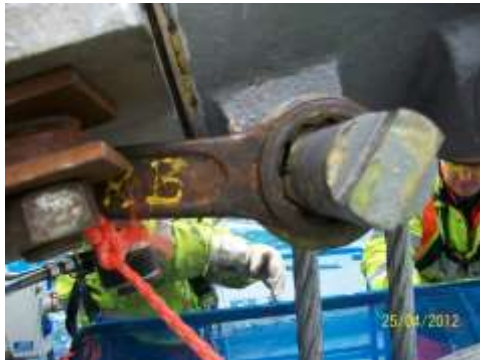
Bolt began to turn, flogging spanner applied to live side to counteract this movement.

It should be recorded that constant pressure was applied on electric pump at 6000 psi for over an hour to release Bolt "D" this was completed at 15.20.pm.

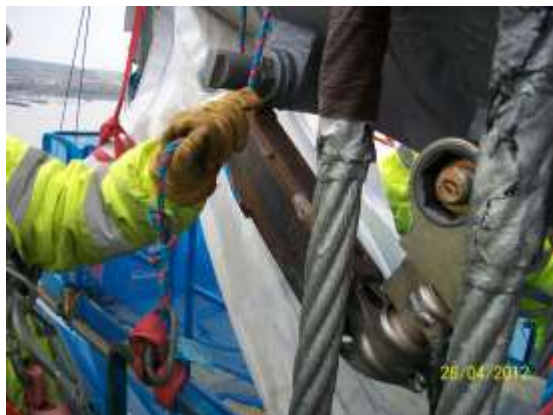
This was not achieved from the live side. Discussions between team resulted in applying the RSL 6.to the dead side.

RSL. 6. Applied to dead side. Torque pressure applied continuously at output of 6000 psi on pump to increase to required specified load of between. No further gain achieved. This combined with problems with power in the batteries on the Bolt scan machine meant that no further readings could be taken.

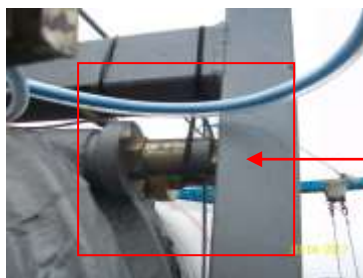
PP20 N/W BOLT "C"

<u>Bolt No.</u>	<u>Load.</u>	<u>Final extension.</u>
Bolt "A" -	101	809.3 Kn.	2.36. mm
Bolt "B" -	117 ( New bolt )	737.6 Kn.	2.15. mm
Bolt "C" -	103	no readings taken, unable to remove cap. Hand-strand obstruction.

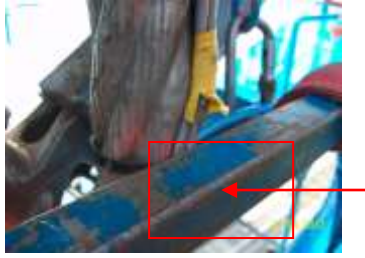
Following completion of works it was recorded ( Photographically and by “ E” MAIL to R.McCulloch, C. Tracey & K.Perryman. ) That the acoustic monitoring cables located on the suspenders at the cable band on the west side ( live ) had been damaged . The external protective core had cuts on both cables . Unable to report that any internal damage had occurred

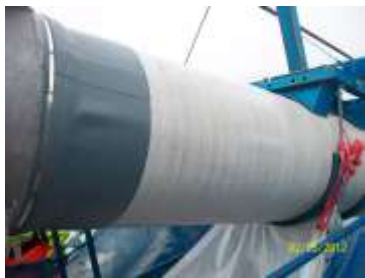
East side

11.55 pm. Visited location to inspect cable wrapping carrier out by Spencers. Found to be in a satisfactory condition. Photographic evidence taken.
