INSPECTION DEPARTMENT
Mainspan upper front Pl. Redundant conduit.
DATE. 13/06/10

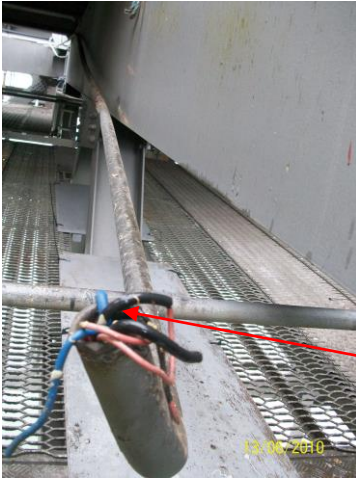
Wires cut at both ends

Photographs of redundant lighting standard supply conduit that requires to be removed from north face of cross girder at PP 70 North East side of only.

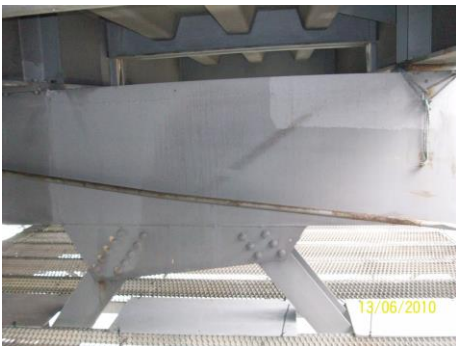
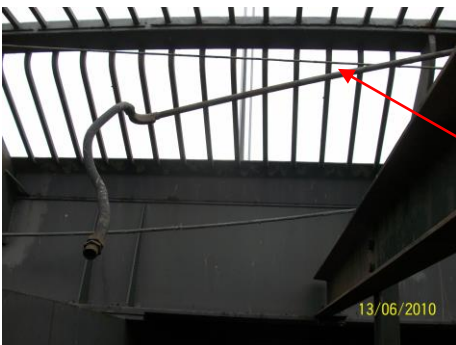
PP 70 north on centre grillage .
conduit unsupported hanging down.

Defect removed by engineer at time of Inspection. Date : 13/06/10.
