# The STEEL PROTECTION CONSULTANCY Ltd.

## REPORT

CLIENT	Atkins		CLIENT'S REF. NO.	5088418	
PROJECT	Forth Road Bridge, Access Walkways Project		SPC PROJECT NO.	1716 B	
LOCATION	Forth Road Bridge, S. Queensferry, Edinburgh		CONTRACTOR	Raynesway	
REPORT NO.	2	VISIT DATE	29 SEP 10	REPORT DATE	01 OCT 10
INSPECTOR

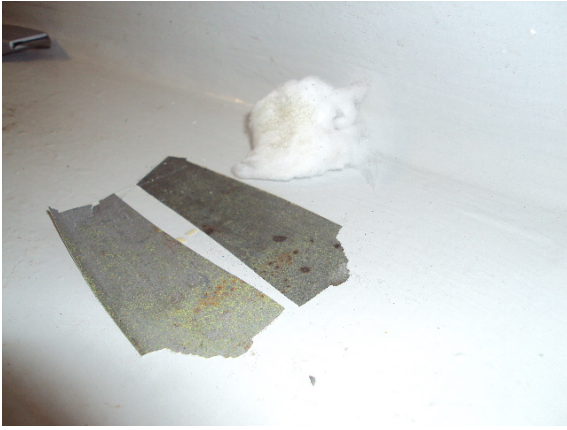
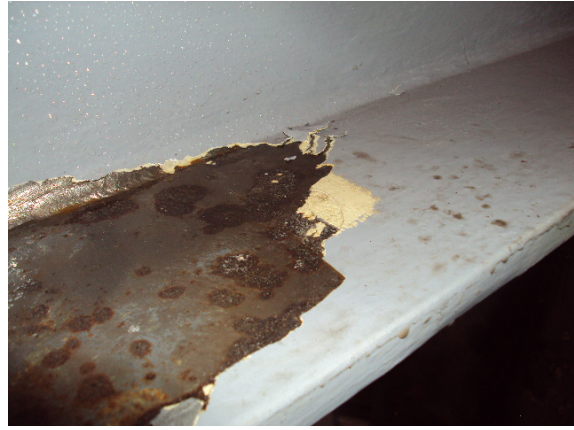
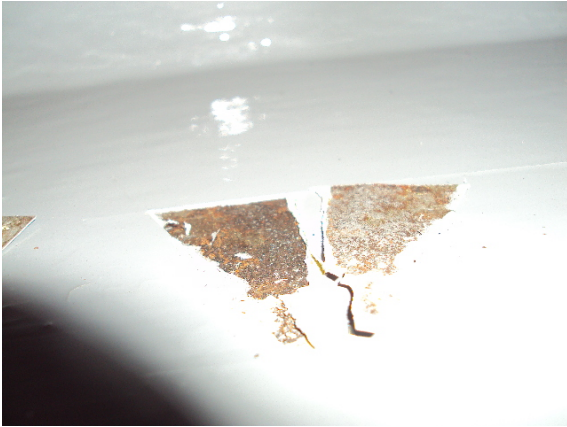
• 3.4 As various stripped areas are larger and some have been exposed for up to 48 hours, it is now clear that the substrates are not bare steel but overcoated with metal spray, presumed to be of zinc. Points of breakdown and rusting were noted.

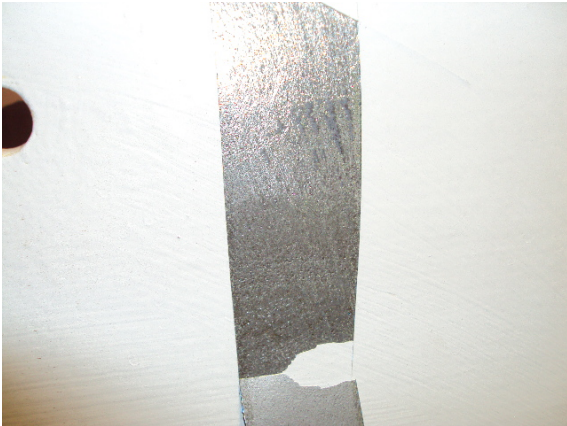
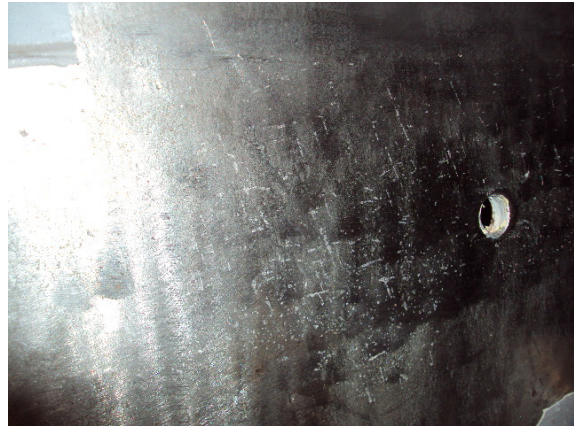
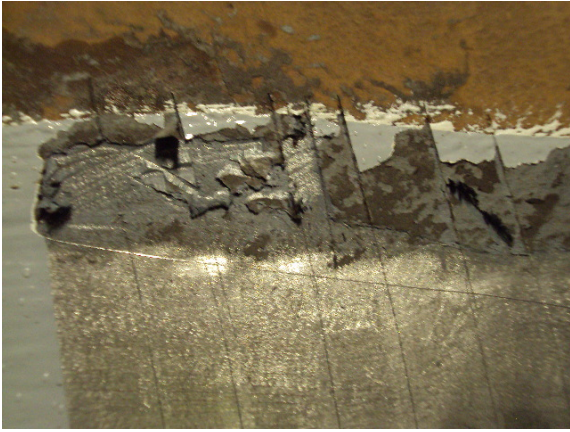
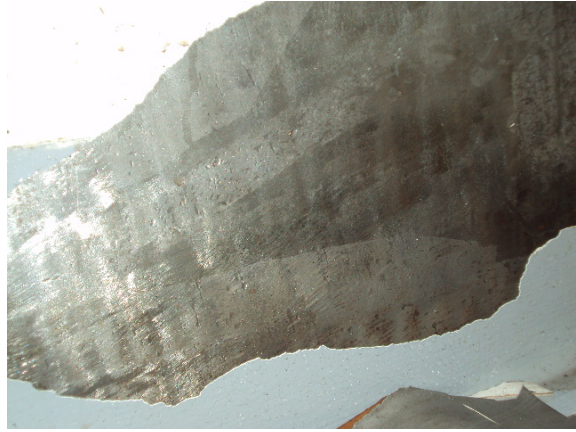
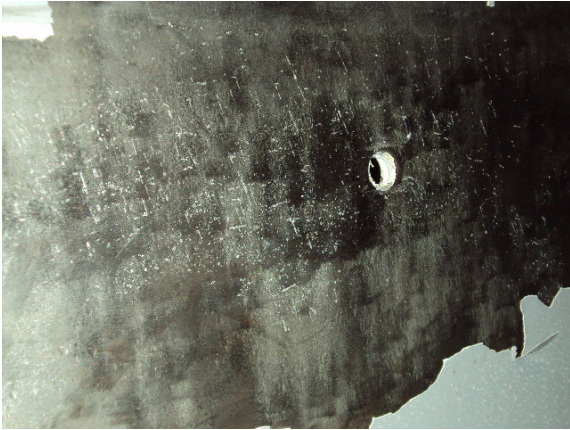
- 3.5 Surface preparation varied widely, with different areas showing :-
  - areas substantially deformed by scabblers
  - other surfaces scabbled with power wire brushing
  - some surfaces prepared by wire brush only, resulting in a highly polished surface (contrary to specification).

- 4.1 That International Paint's conclusion that the lack of adhesion is due to solvent entrapment is probably the principal cause.
- 4.2 Further to 4.1 above, that the wide variation of surface preparation, in particular the polishing of surfaces by power wire brush, is contrary to specification and is probably a contributory factor.
- 4.3 A further contributory factor could be the inclusion, and possibly distribution over the surfaces by solvent action, of residues of previous coatings.

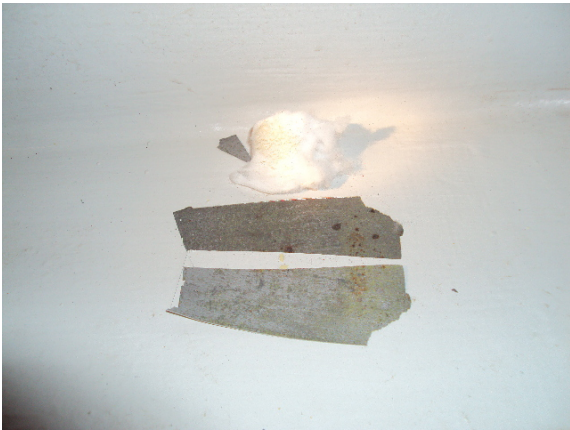
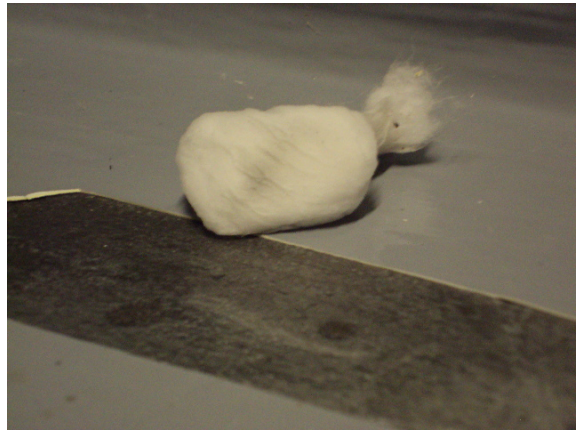
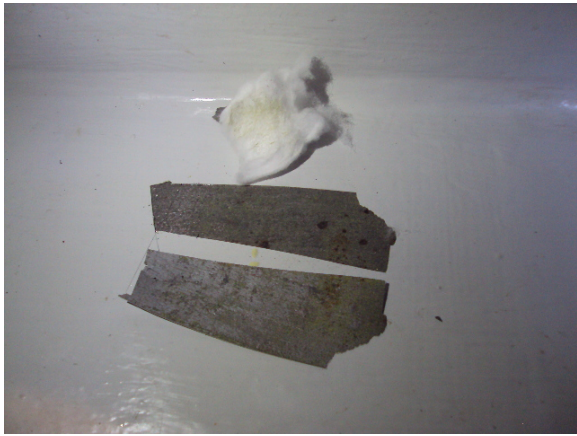
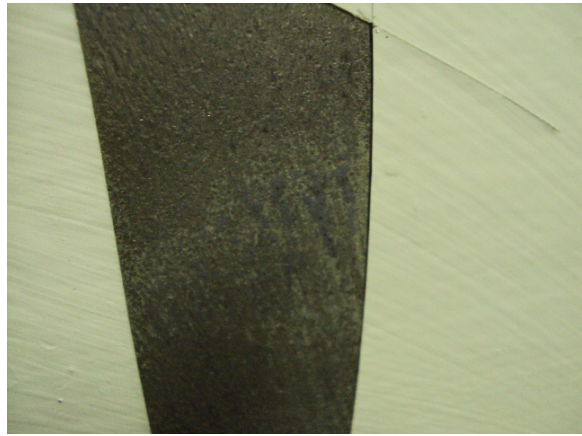
- 3.6 On many of the surfaces (exposed metal and/ or underside of paint flakes) which had been exposed for some time, it was noted that there was a thin film of yellowish grey-green contamination. Water swabbing had little or no effect on this material which was concluded to be non water-soluble and the discolouration that was lifted was presumed to be recent dirt.

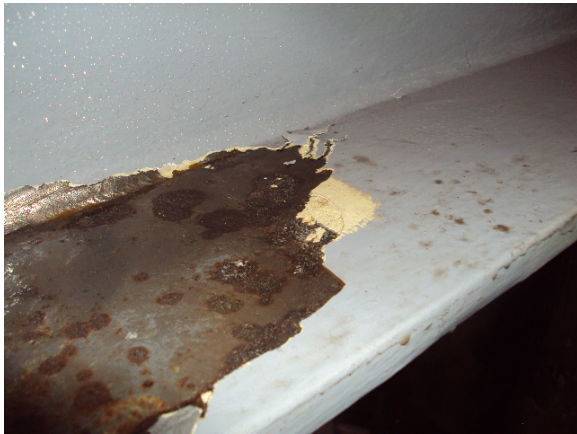
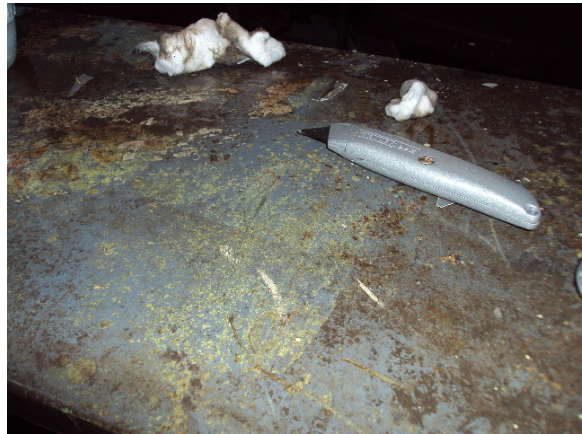
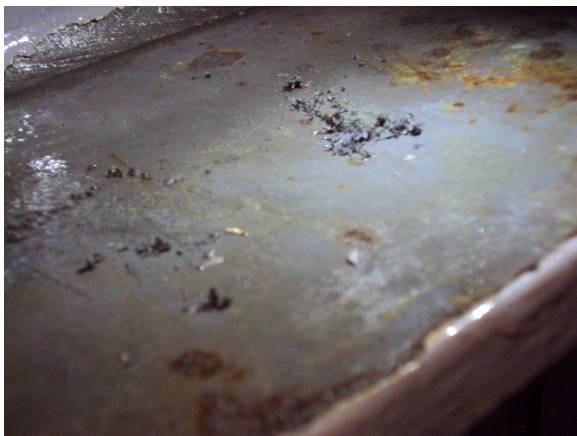
- 3.7 Some areas were noted with varying amounts of old coatings adhering to the substrate

In this context, it should be noted that the Form HA/ P1 specifies application to “... bright steel or bright metal coating ...”, while Procedure Document Ref. 5088418 DOC OUT 0054, Sections 3 (New Steel to Existing Steel), 4 (Bolted Connections) and 5 (Repair of mechanically damaged areas on New Steel) include reference to overcoating of sound existing coatings. In the latter document, the intention is presumably that this should apply to damaged areas and feathering edges but not to substantial areas and the presence of sizeable areas of previous coating would therefore be contrary to specification – clarification might be helpful.
