INSPECTION DEPARTMENT
N.W. . NW
DATE: 2014.05.01.

NORTH WEST TROUGH WELD SURVEY

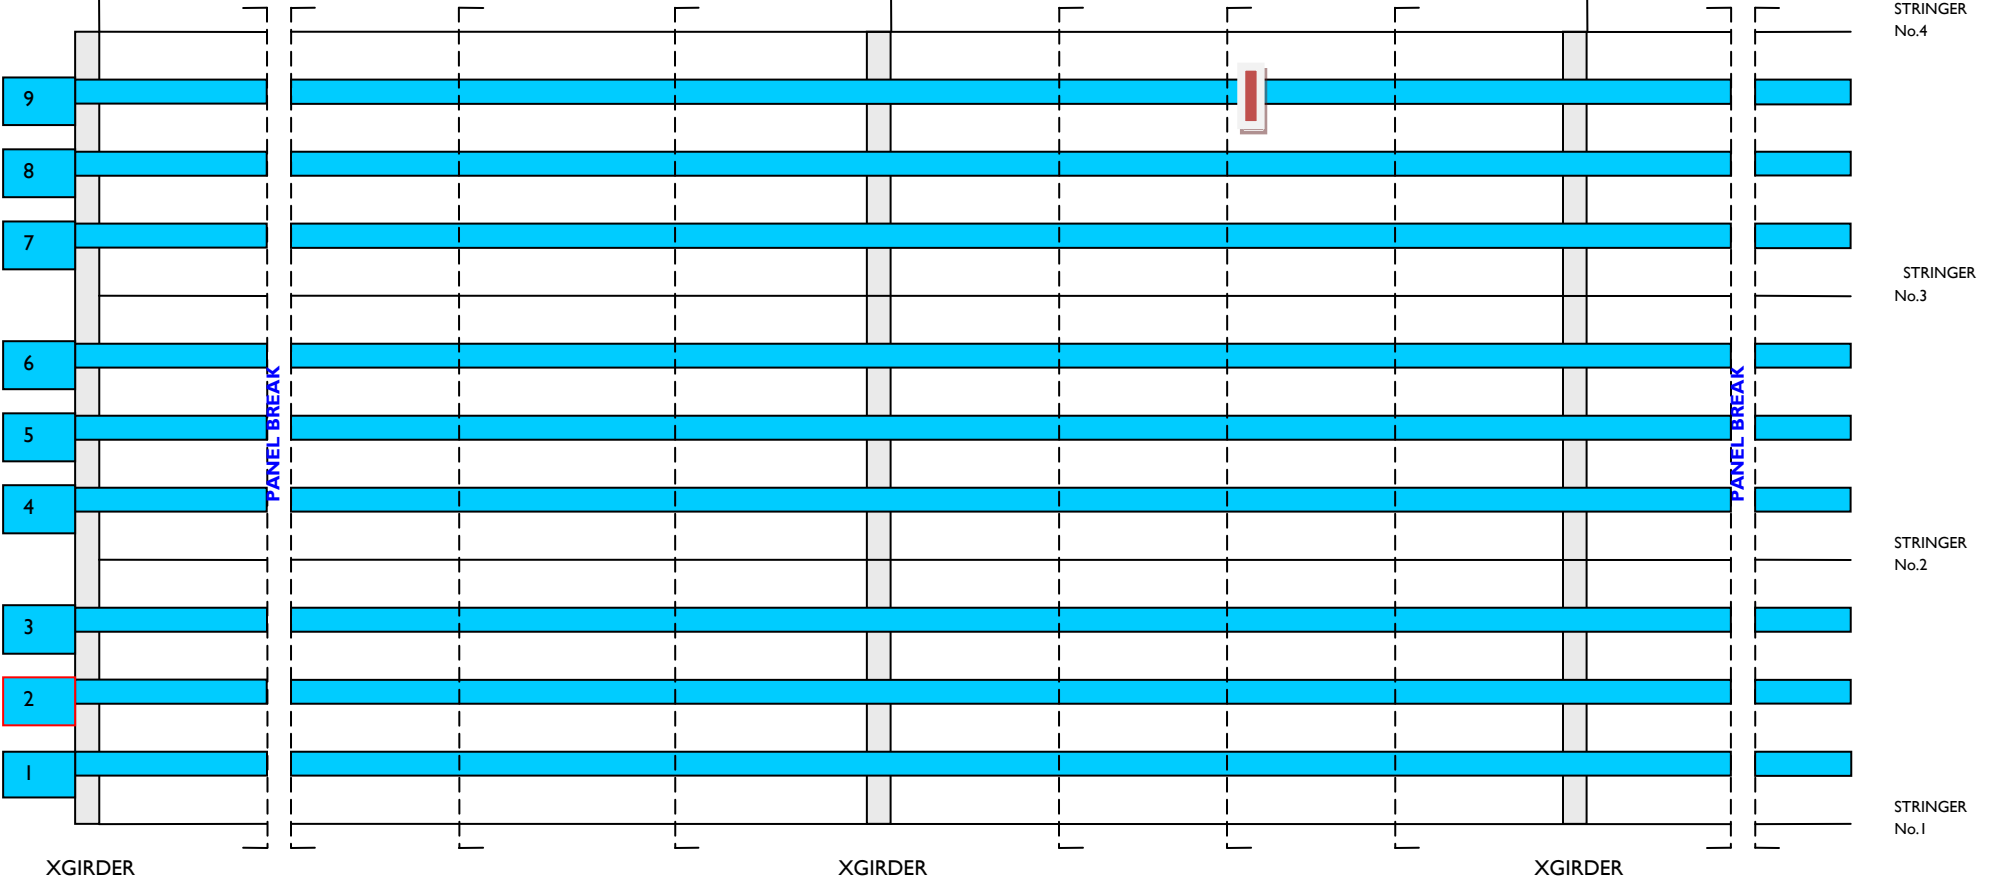
WELD. 120mm.

Paint blistered at this trough. Appears to be water bubble. Slight area of teardrop staining on face.
