Inspection was required due an accident at cross-over 3 south bull nose on the east side (southbound) on 30/12/09 at 16:50hrs.

Bridge Inspectors

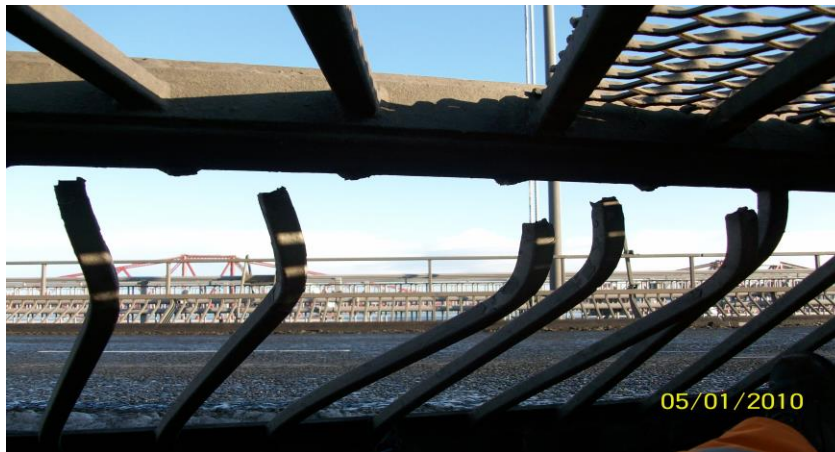
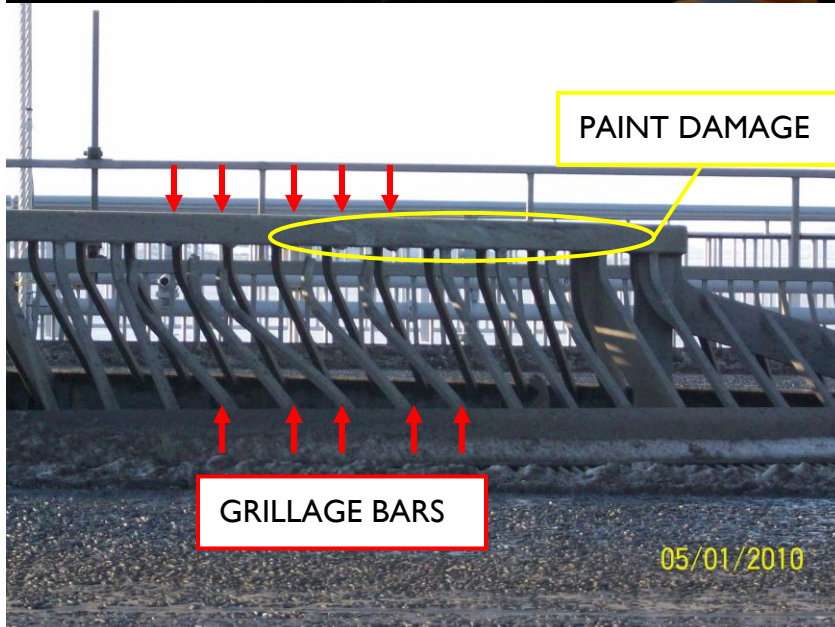
On inspection it was found that there were five grillage bars bent and sheared at top connection points, with minor paint damage to hollow section.

All bars are secure at bottom welds and are projecting inwards (away from traffic).

Grillage bars remain in a relative safe condition, until proper repairs can be carried out.
