INSPECTION DEPARTMENT
Main Span North West Crash barrier / Handrail.
DATE. 06.01.15

### MAIN SPAN NORTH (WEST)

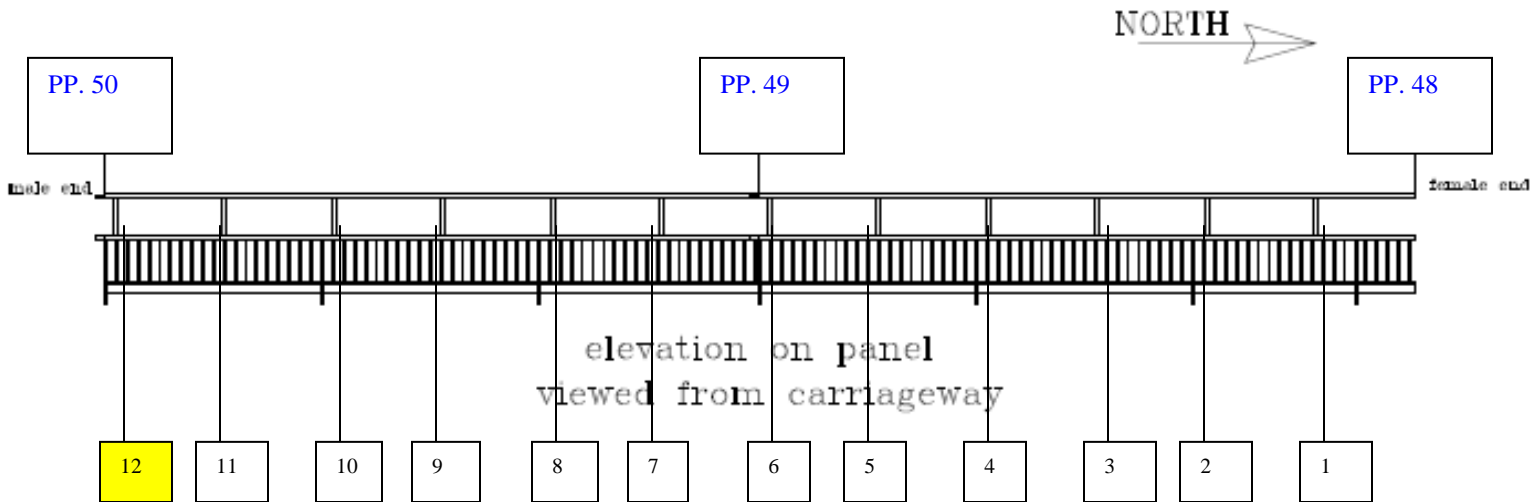
- Top Rail. -
- Post No1.-
- Post No2.-
- Post No3.-
- Post No4.-
- Post No5.-
- Post No6.-
- Post No7.-
- Post No8.-
- Post No9.-
- Post No10.-
- Post No11.-
- Post No12.- Bottom weld cracked East & West faces
- Bottom Rail.-
- Grillage.-

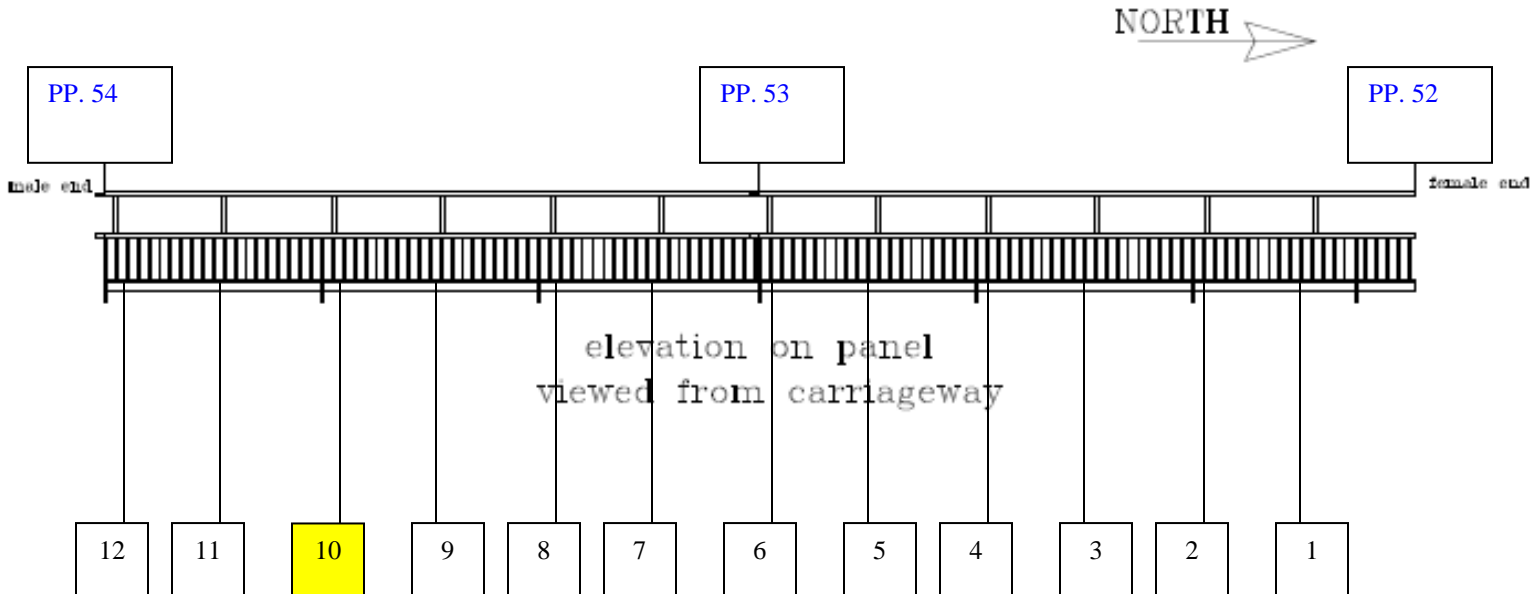
MAIN SPAN NORTH (WEST)

- Top Rail. -
- Post No1.-
- Post No2.-
- Post No3.-
- Post No4.-
- Post No5.-
- Post No6.-
- Post No7.-
- Post No8.-
- Post No9.-
- Post No10.- Slight impact damage – welds secure, dentation evident
- Post No11.-
- Post No12.-
- Bottom Rail.-
- Grillage.-

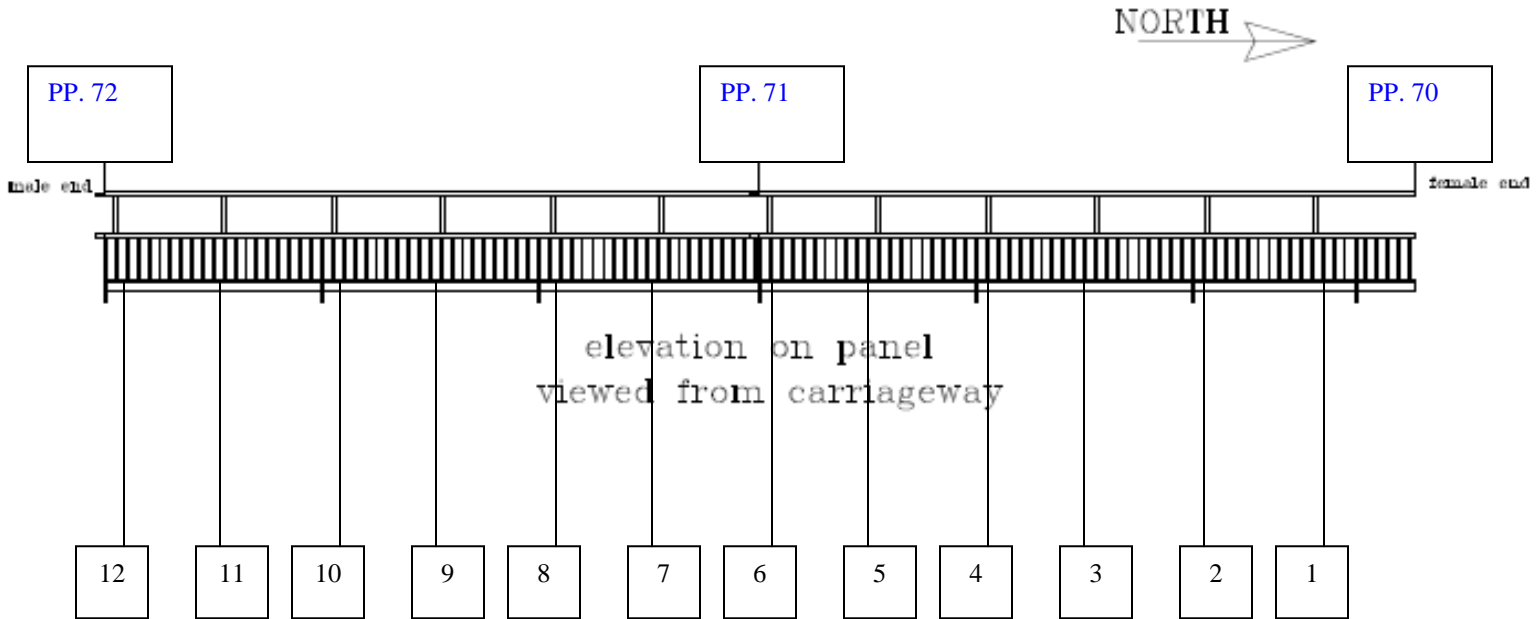
MAIN SPAN NORTH (WEST)

- Top Rail. - New detail expansion joint – bolt pulled through PP70
- Post No1.-
- Post No2.-
- Post No3.-
- Post No4.-
- Post No5.-
- Post No6.-
- Post No7.-
- Post No8.-
- Post No9.-
- Post No10.-
- Post No11.-
- Post No12.-
- Bottom Rail.-
- Grillage.-

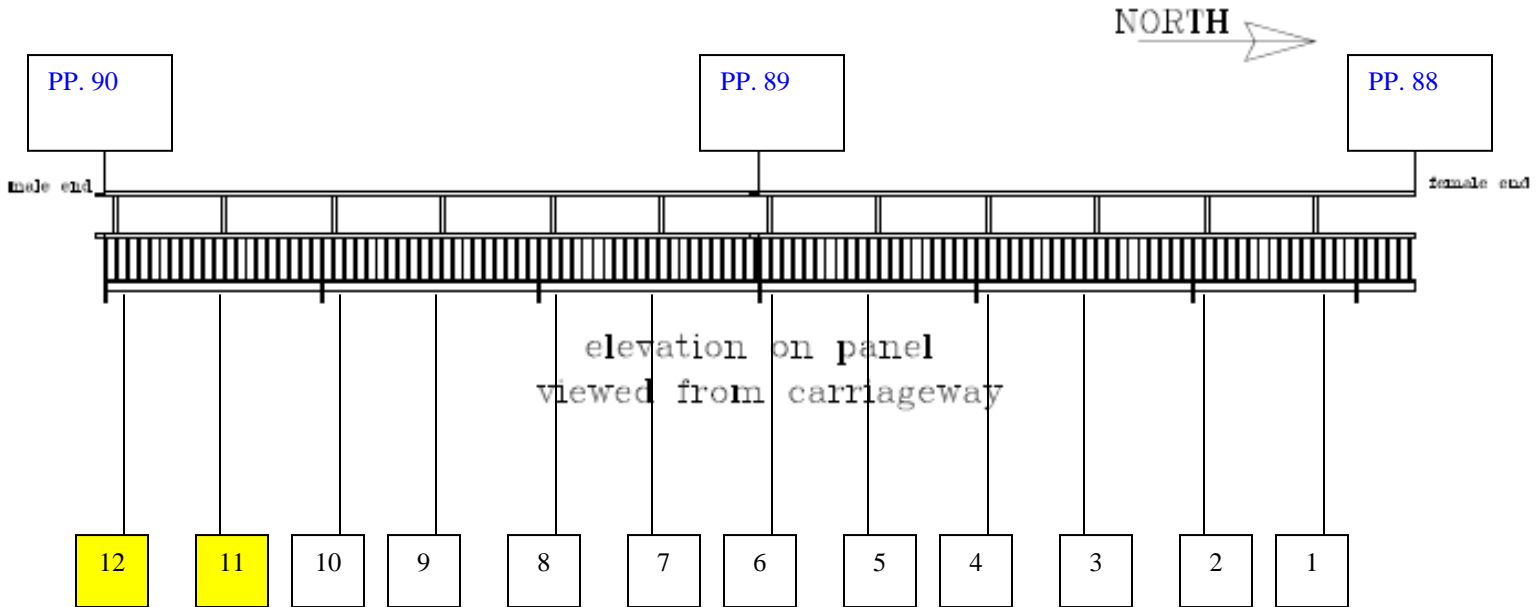
### MAIN SPAN NORTH (WEST)

- Top Rail. -
- Post No1.-
- Post No2.-
- Post No3.-
- Post No4.-
- Post No5.-
- Post No6.-
- Post No7.-
- Post No8.-
- Post No9.-
- Post No10.-
- Post No11.- Bottom weld has come away from bottom rail – currently plated either side
- Post No12.- Bottom weld to bottom rail cracked all the way round – plate required
- Bottom Rail.- Top of rail at post no. 12 corroded right through
- Grillage.-

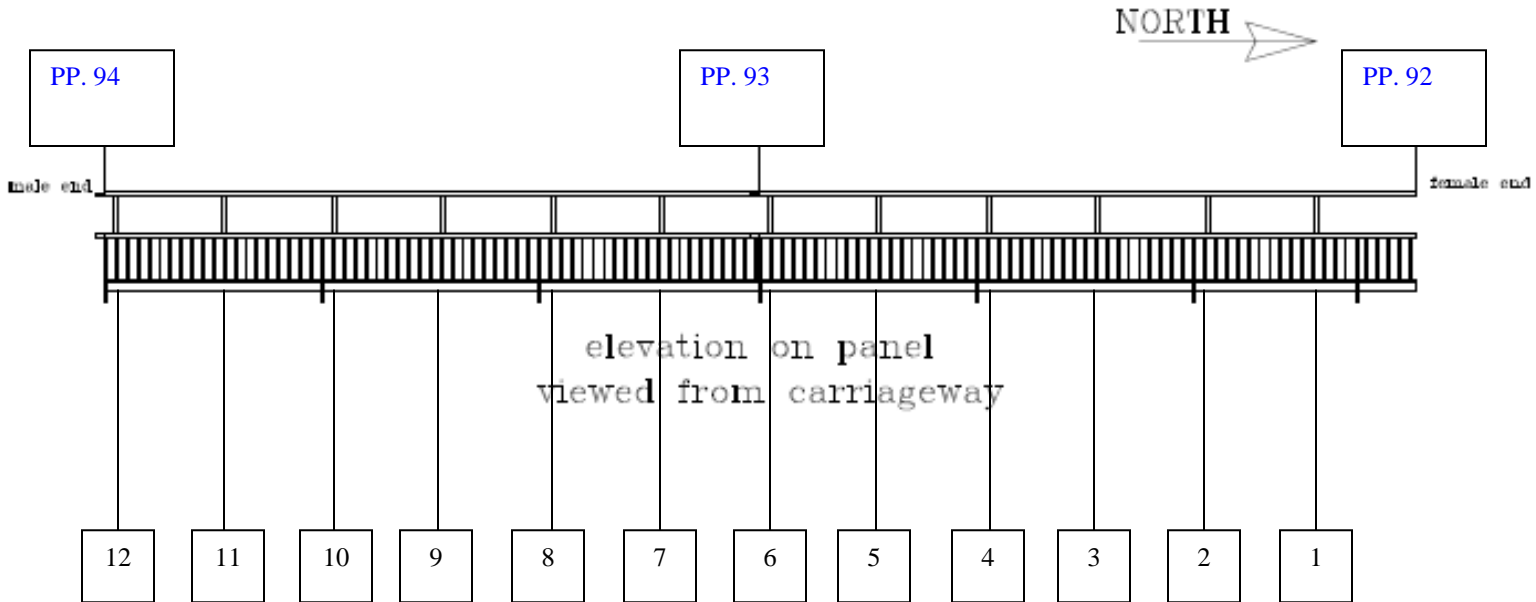
MAIN SPAN NORTH (WEST)

- Top Rail. - New detail expansion joint 2 no. set screws missing
- Post No1.-
- Post No2.-
- Post No3.-
- Post No4.-
- Post No5.-
- Post No6.-
- Post No7.-
- Post No8.-
- Post No9.-
- Post No10.-
- Post No11.-
- Post No12.-
- Bottom Rail.-
- Grillage.-

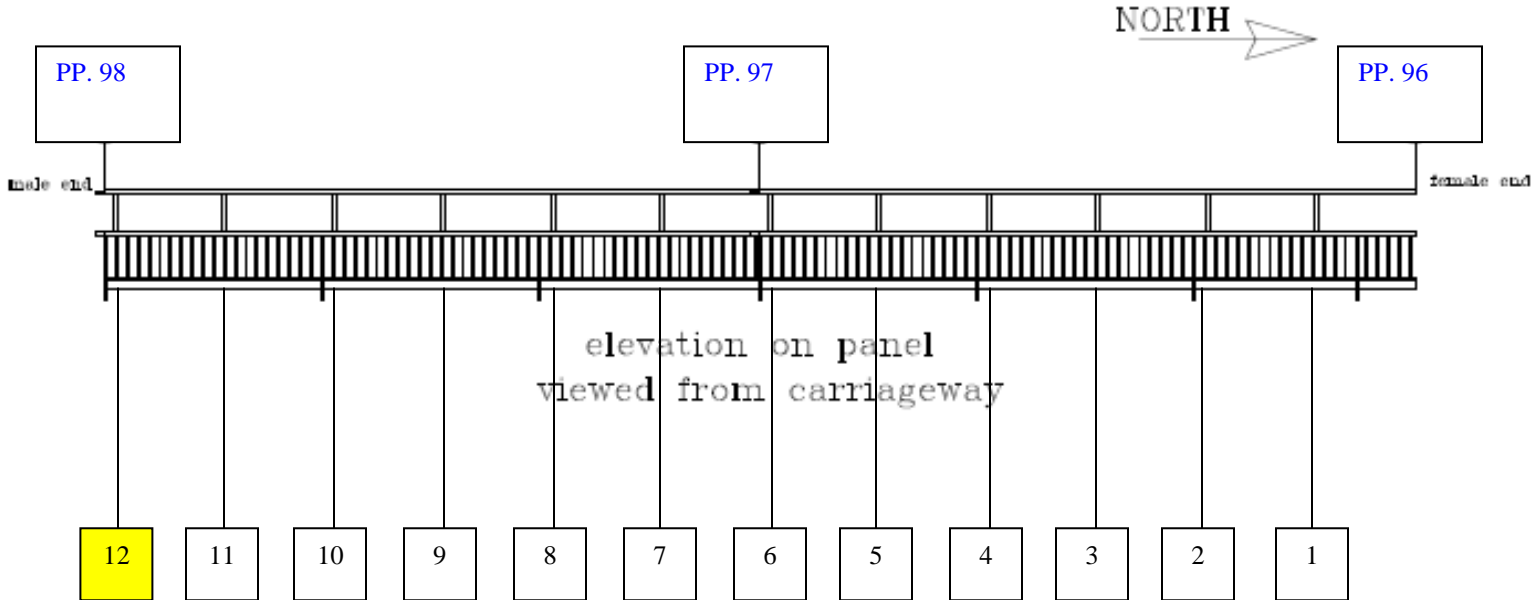
MAIN SPAN NORTH (WEST)

- Top Rail. -
- Post No1.-
- Post No2.-
- Post No3.-
- Post No4.-
- Post No5.-
- Post No6.-
- Post No7.-
- Post No8.-
- Post No9.-
- Post No10.-
- Post No11.-
- Post No12.-
- Bottom Rail.- Post no. 12 holed on top section of bottom rail south side of post
- Grillage.-
