# A90 Forth Road Bridge Special Inspection Report

North Main Tower Expansion Joint  
Removal & Reinstatement of Side-Span Plate  
SW No.3  
October 2015

#### **North Main Tower Expansion Joint Removal & Reinstatement of Side-Span Plate SW No.3**

**October 2015**

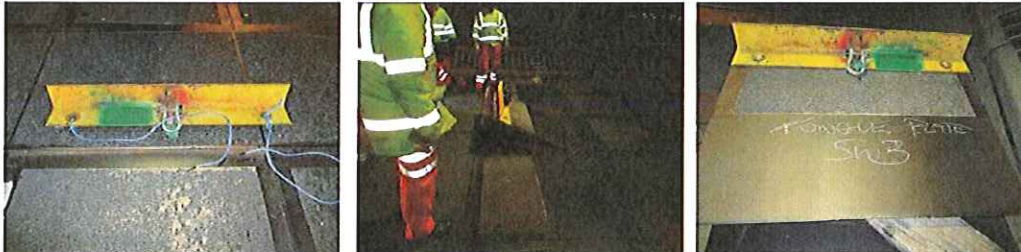
Tongue plate: Tongue plate lifting bracket attached using existing spring holes & secured using specified bolts. Plate lifted & laid down by crane. No problems were encountered during lift.

Tongue plate end bearing blocks: Both blocks located on the east & west side of the bearing ledge remain intact & secure.

**Fixing of lifting eye beam for removal of slide train**

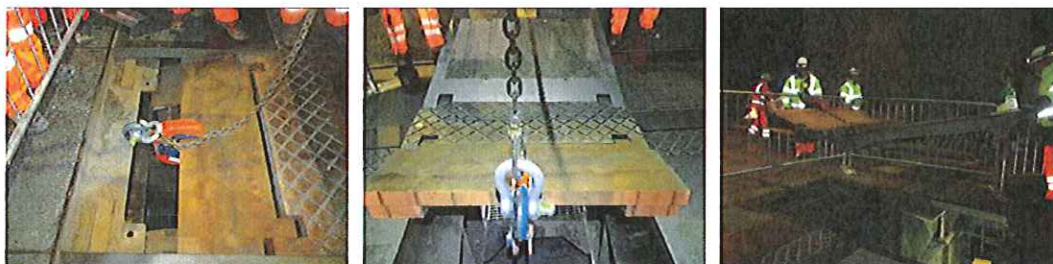
Rocker & sliding plate: Fixed lifting eye attached to plate using existing rocker plate spring hole & secured using specified bolt. Plate lifting clamp was attached to sliding plate section No 2 and secured. Crane lift took place. On lift, resistance was found in the south east corner between sliding plate leaf No 2 & the west face of the sliding plate on N\W No 4. The reason for the resistance was due to unequal gaps between the two leaves of the sliding plates. This was rectified by the use of a lever bar to which force was applied to ease the pressure on both faces. This method proved to be successful and the lift continued and was completed without any further issues. On lift the plate was laid on its surface side to allow inspection of the all sliding plate links, pins and bushes. All welds on the links to sling plate sections were visually inspected, all were found to be in a satisfactory condition. It was decided that no further method of inspection would be considered.

**Removal of slide train**

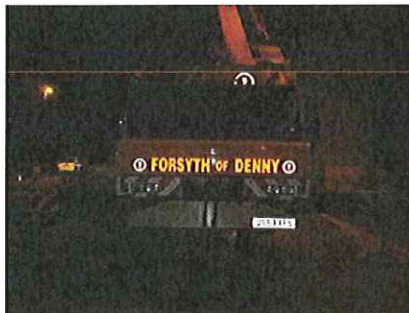
Crane for Removal & Reinstatement of Slide Train

A visual inspection was carried out from the cell and this proved to be successful. All plates seated correctly.

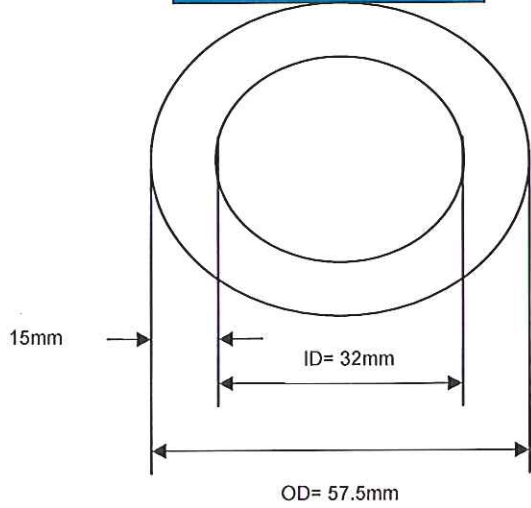
New spring ( E )

MEAN DIA. = 45mm

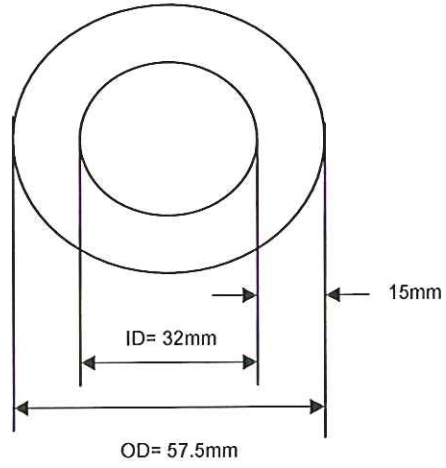
New spring ( W )

MEAN DIA. = 45mm

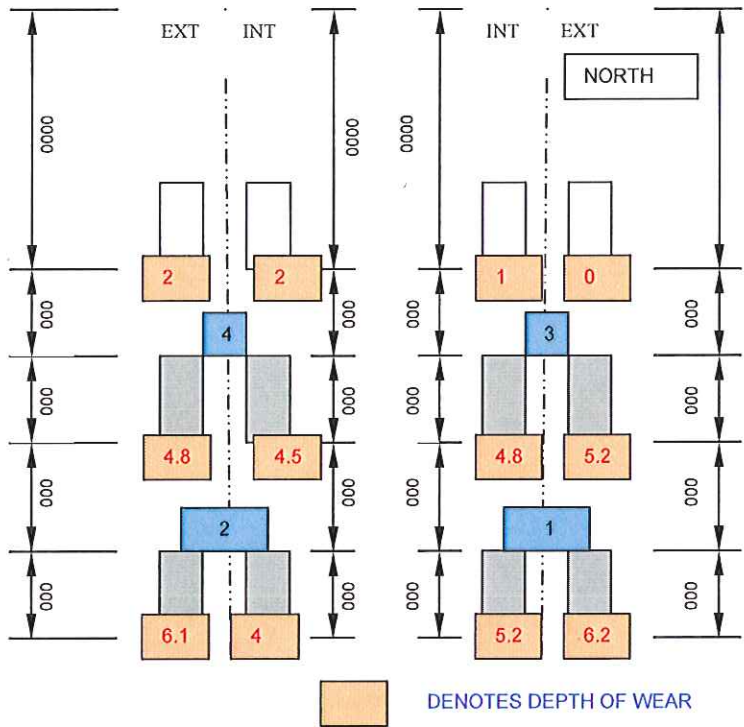
Pin No.		Internal Dia.	External Dia.
1		39mm	39mm
Bush Thkns	Top	5 mm	5 mm
	Bottom	3 mm	3 mm
	North	3.5 mm	0 mm
	South	3.5 mm	3.5 mm
Pin No.		Internal Dia.	External Dia.
2		39mm	39mm
Bush Thkns	Top	0 mm	6 mm
	Bottom	3 mm	2.5 mm
	North	3 mm	0 mm
	South	1.5 mm	4.5 mm
Pin No.		Internal Dia.	External Dia.
3		39mm	39mm
Bush Thkns	Top	2 mm	2.5 mm
	Bottom	4 mm	2 mm
	North	5 mm	0 mm
	South	3 mm	1.5 mm
Pin No.		Internal Dia.	External Dia.
4		39mm	39mm
Bush Thkns	Top	0 mm	5 mm
	Bottom	0 mm	0 mm
	North	0 mm	0 mm
	South	0 mm	3 mm

Bush bore dimensions :- ( largest across oval, horizontal axis. ) - No dimensions taken

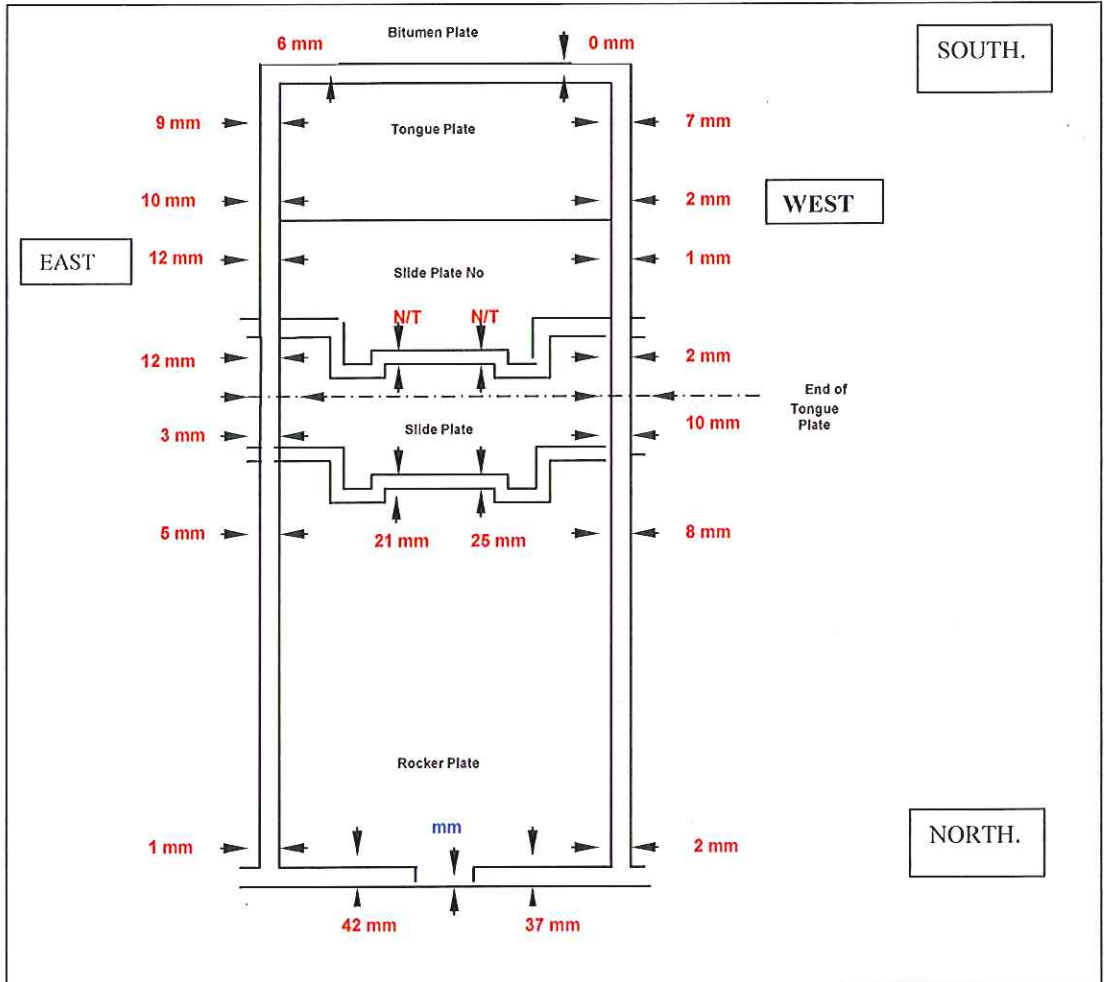
Inspection Record Sheet:-	
Subject :- Demag plate set removal.	
Pre-removal Dimensional Checks	
Inspected by:	
Date:	2015.10.24

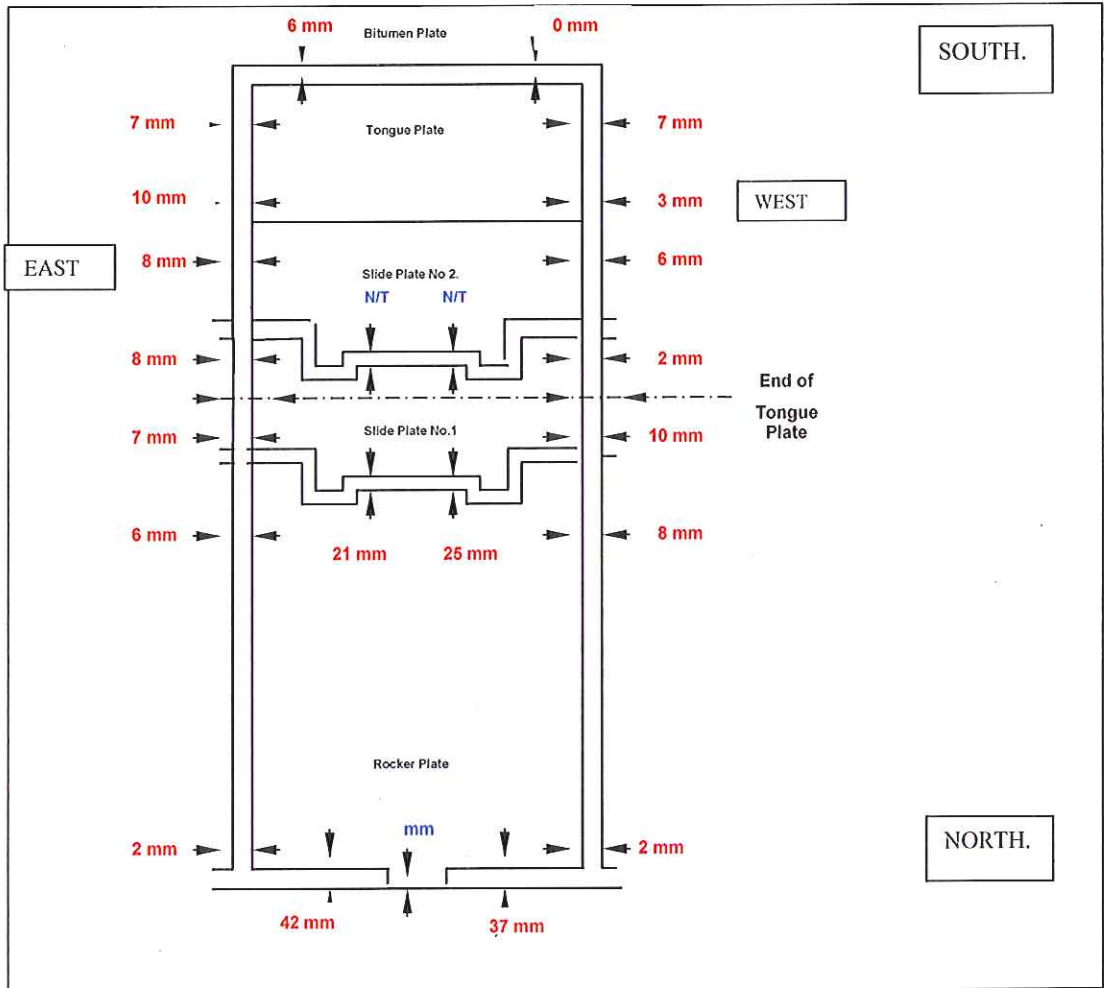
Inspection Record Sheet:-			
Subject :- Demag plate set removal			
Post -removal Dimensional Checks			
Inspected by:			
Date:	2015.10.24.

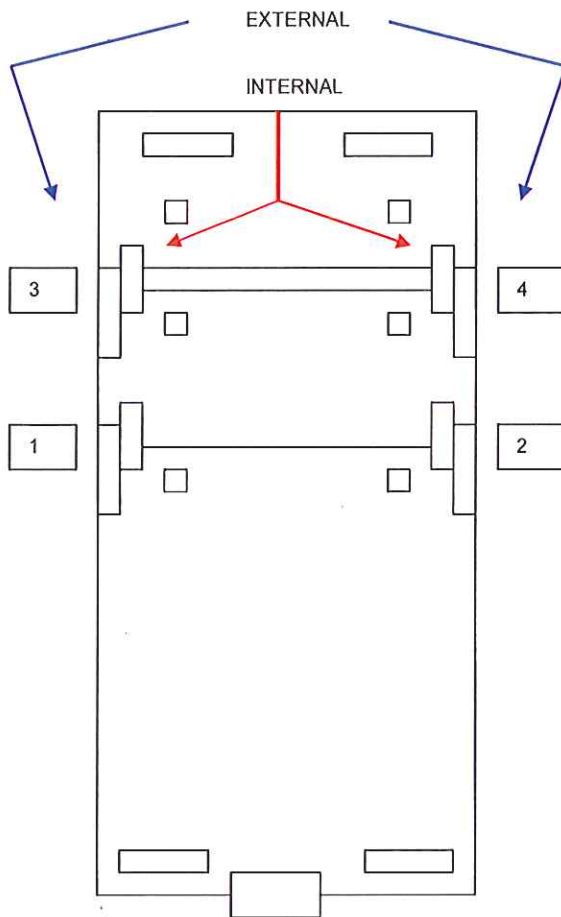
INSPECTION DEPARTMENT
DEMAG DIMENSIONAL BLANK . PINS & BUSHES. SW 3.
DATE. 2015.10.24.

PIN No.	EXTERNAL	INTERNAL
<u>1</u>	39mm	39mm
<u>Bush thickness</u>		
Top	5 mm	5 mm
Bottom	3 mm	3 mm
North	0 mm	3.5 mm
South	3.5 mm	3.5 mm
<u>2</u>	39mm	39mm
<u>Bush thickness</u>		
Top	6 mm	0 mm
Bottom	2.5 mm	3 mm
North	0 mm	3 mm
South	4.5 mm	1.5 mm
<u>3</u>	39mm	39mm
<u>Bush thickness</u>		
Top	2.5 mm	2 mm
Bottom	2 mm	4 mm
North	0 mm	5 mm
South	1.5 mm	3 mm
<u>4</u>	39mm	39mm
<u>Bush thickness</u>		
Top	5 mm	0 mm
Bottom	0 mm	0 mm
North	0 mm	0 mm
South	3 mm	0 mm
